STUDY #1 IN A SERIES OF REPORTS ON RADON IN BC HOMES

A Comparison of Three Radon Systems in British Columbia Homes:

CONCLUSIONS AND RECOMMENDATIONS FOR THE BRITISH COLUMBIA BUILDING CODE

OCTOBER 2014

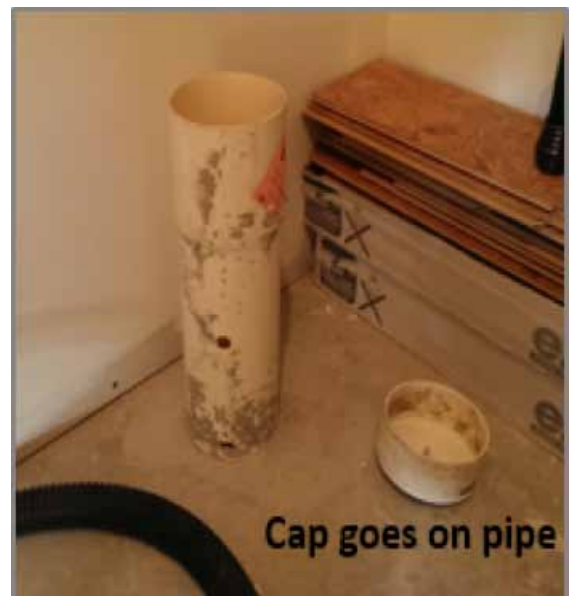
While this home was identified as meeting the year of construction criteria it clearly was not compliant with the 2012 Code in several ways:

- The rough-in pipe had not been capped by the home builder and simply left on the floor, and this situation was not observed during final inspection by the Code compliance authority.
- The radon pipe was perforated. Even if the cap had been placed the perforations in the pipe allowed radon entry into the home.
- The cost of fixing this issue and then making extensive internal alterations to install a passive pipe system through finished space to the roof would have been prohibitive.

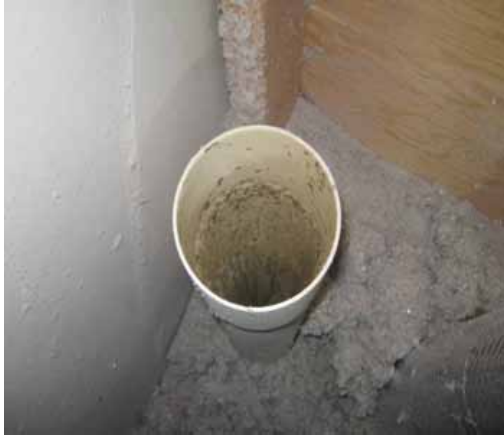
Figure 5. Example of Pipe Venting Into Attic

In 2 of 16 homes the radon pipe was venting into the attic (Figure 5).

Issue - Radon venting into attic increases risk of radon levels in living space, condensation may form on the pipe and affect insulation and water on ceiling, and mold may establish in attic space.

Solution - Ensure radon pipe is vented out the roof (Figure 6).

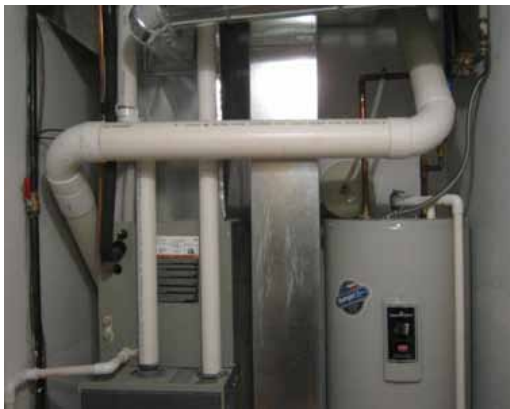
Figure 7. Example of Pipe Run Unsupported

In 6 of 16 homes horizontal runs of the radon pipe were unsupported (Figure 7).

Issue - Radon pipe could bend, move, or become unattached.

Solution - Provide adequate bracing along the horizontal runs of pipe (Figure 8).

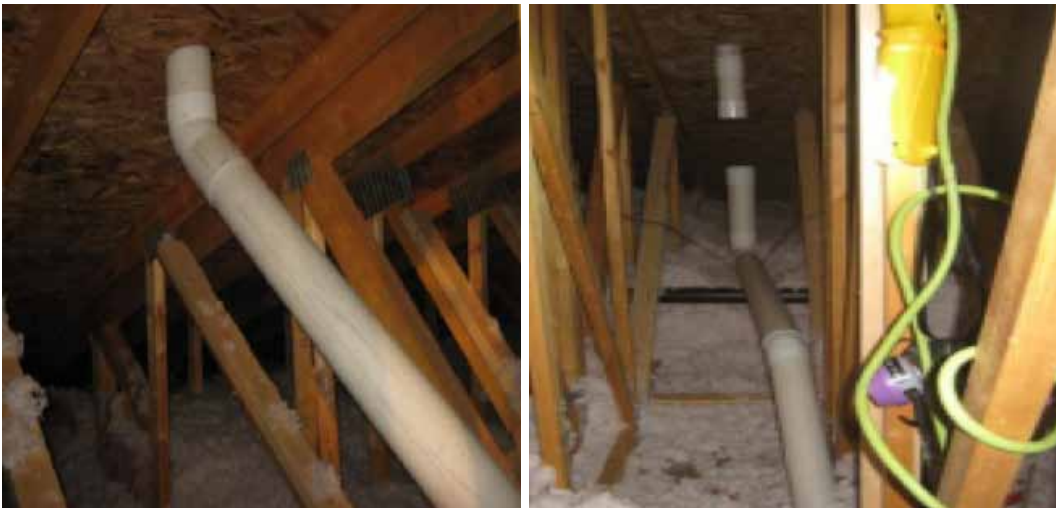
Figure 11. Example of Radon Pipe Positioned on Angle Figure 12. Example of Radon Pipe Cut and Straightened

In 2 of 16 homes the radon pipe was positioned in the attic on an angle (Figure 11).

Issue - A radon fan installed to a radon pipe on an angle may get moisture pooling in the fan casing. This will impact the efficacy of the radon fan.

Solution - Ensure that the radon pipe exiting the attic is completely vertical (Figure 12).

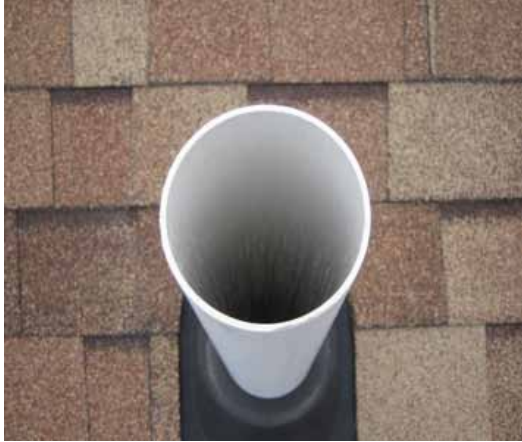
In all 16 homes the radon pipe exiting the roof was unscreened (Figure 13).

Issue - Debris may fall into the pipe and block the flow.

Figure 13. Example of Radon Pipe End with No Screen Figure 14. Example of Radon Pipe End with Screen

Solution - Insert a screen onto the end point of the radon pipe (Figure 14).
